Investigation of Neutron-Irradiated Beryllium Pebble Oxidation in Dry and Humid Air at Elevated Temperatures for LOVA/LOCA Estimation and Corresponding Safety Protocol Development

Rūdolfs Jānis Zabolockis^{1,2}, Elina Pajuste^{1,2}, Liga Avotina¹, Gunta Kizane¹

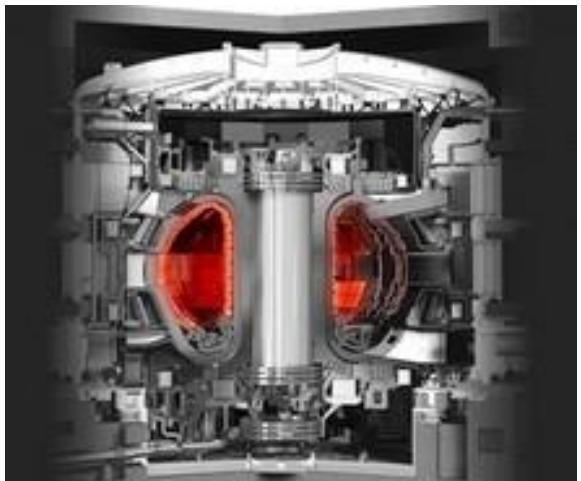
Fig. 1. ITER blanket zone [3]

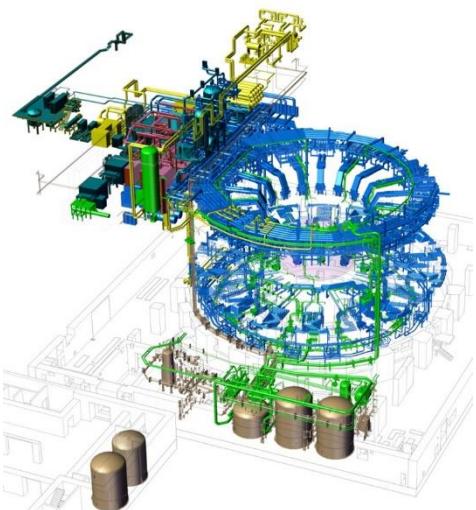
Fig. 2. ITER water cooling system [3]

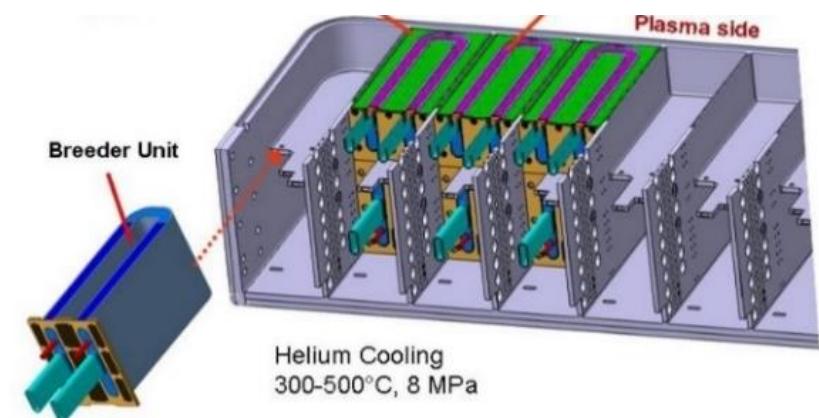
Fig. 3. Helium-cooled pebble bed tritium breeding units [4]

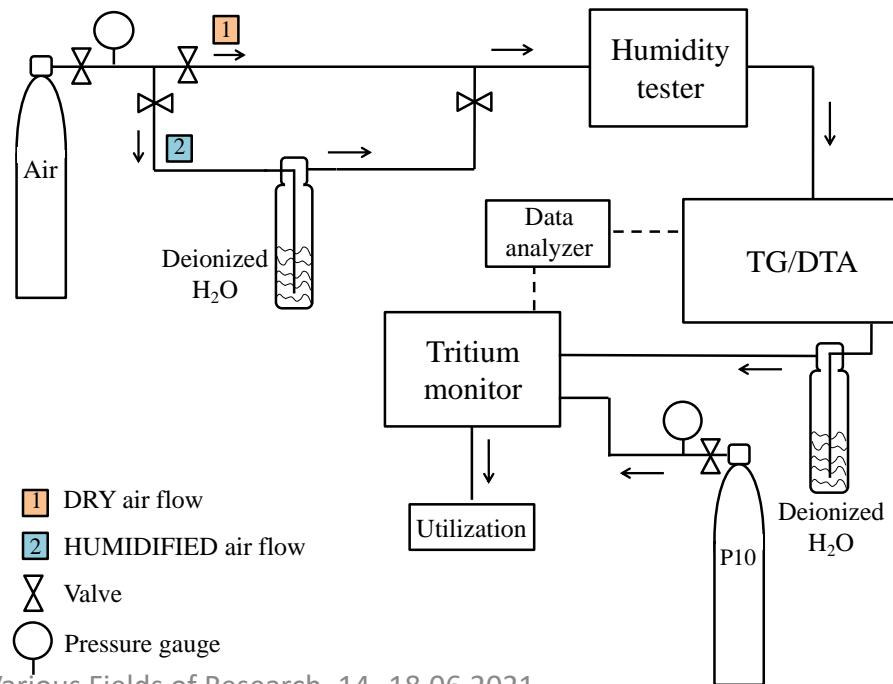
Fig. 1. Beryllium thermal treatment system with humidity control

1. Thermogravimetric/Differential Thermal Analysis (TG/DTA) with SEIKO Exstar 6300; air flow 12 L/h, heating rate 10K/min, up to 1548K.
2. Scanning electron microscopy with Hitachi S-4800 equipped with EDS system Bruker XFlash Quad 5040 123eV.

- Non-irradiated
 - **DRY** ($\text{RH}<5\%$)
 - **HUMIDIFIED** ($\text{RH}>95\%$)
- Neutron-irradiated
 - **DRY** ($\text{RH}<5\%$)
 - **HUMIDIFIED** ($\text{RH}>95\%$)

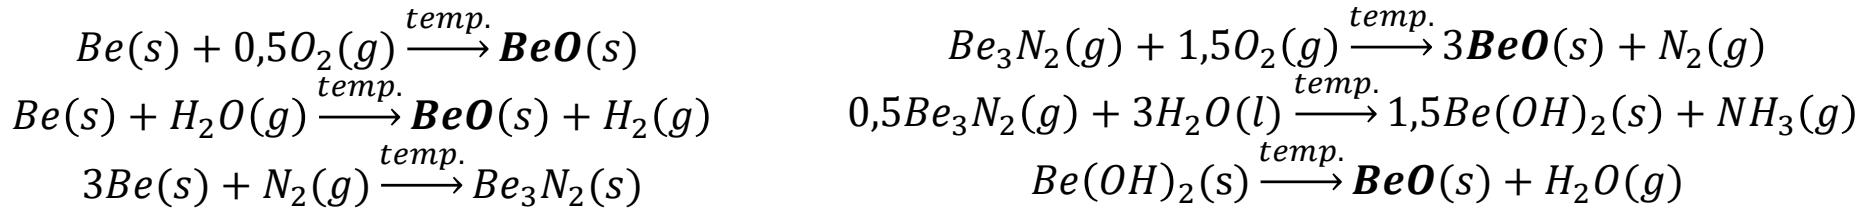
Fig. 1. Chemical reactions between beryllium and corresponding compounds in air/ humid air [1, 2]

TG/DTA shows an **increase of mass** which occurs due to the oxidation of beryllium in the presence of air and water moisture, ultimately leading to beryllium oxide formation. Most notably, neutron-irradiated pebbles in humid airflow exhibit a mass increase of almost **180%**.

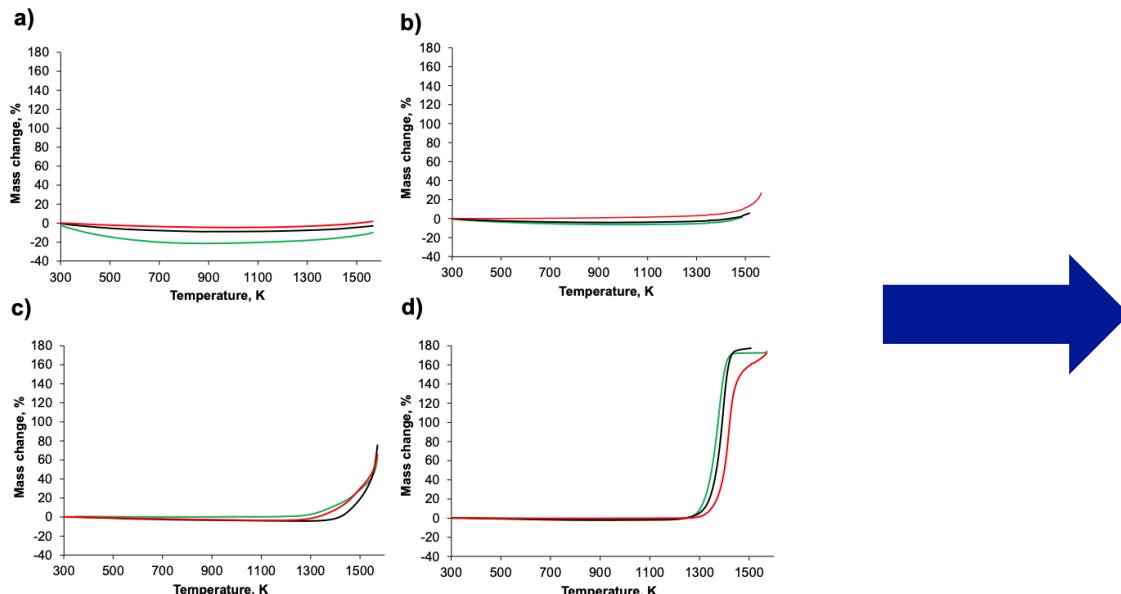
Fig. 2. Mass change of 3 Be pebbles in: a) non-irradiated DRY, b) neutron-irradiated DRY, c) non-irradiated HUMID, d) neutron-irradiated HUMID airflow

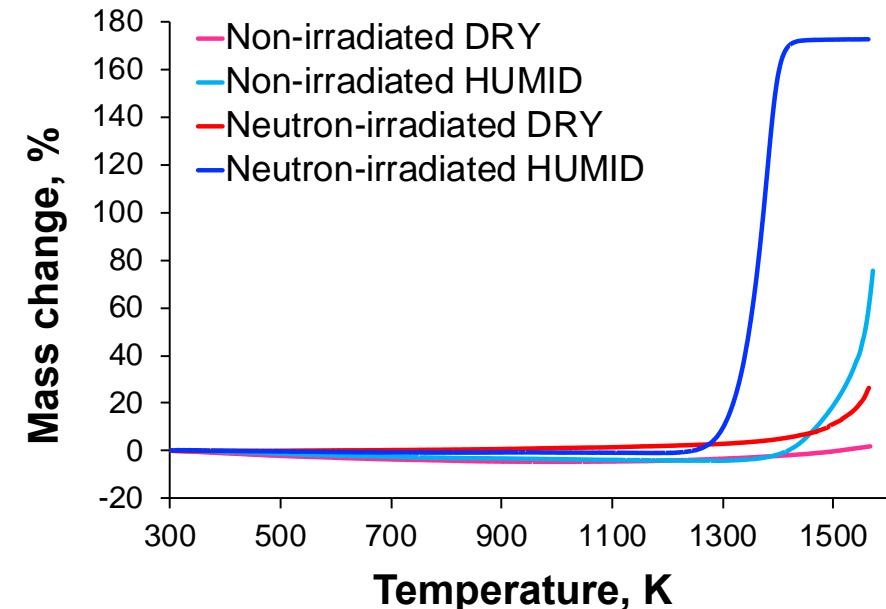
Fig. 3. Mass change of Be pebbles depending on treatment conditions

4. Elevated humidity together with neutron irradiation yield the most significant mass increase (~180%) due to BeO formation.
5. The neutron irradiation causes structural defects as well as through nuclear reactions produces gaseous species within bulk material that ultimately lead to channel formation for the de-trapping of gas. In a fusion reactor, the gaseous mixture would contain fusion fuel that would also be released (hence posing a radiation hazard).

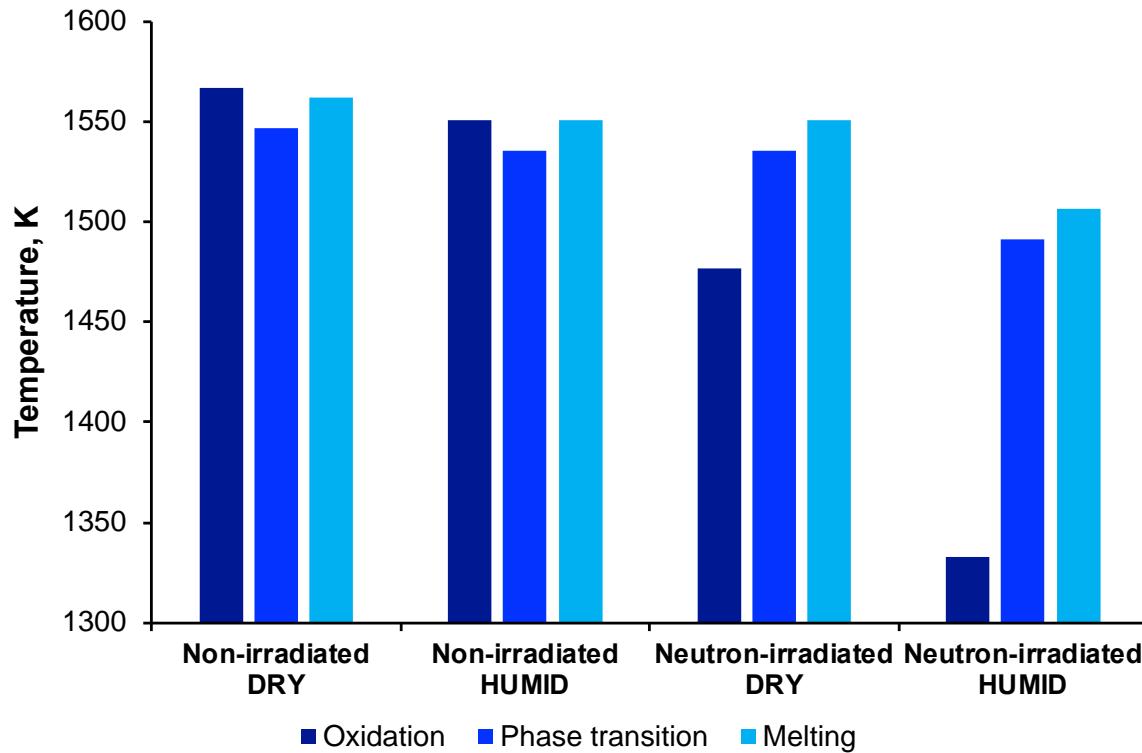
Fig. 1. Beryllium pebble behavior depending on treatment conditions

Beryllium undergoes various thermal processes upon/after commencing rapid oxidation. The temperature at which such processes take place is dependant on the treatment conditions.

It is evident that neutron irradiation can be deemed one of the most important factors impacting thermal process temperatures for Be. However, humidity also has a key role. Elevated humidity exhibits an **augmenting effect**, most significantly impacting the oxidation process.

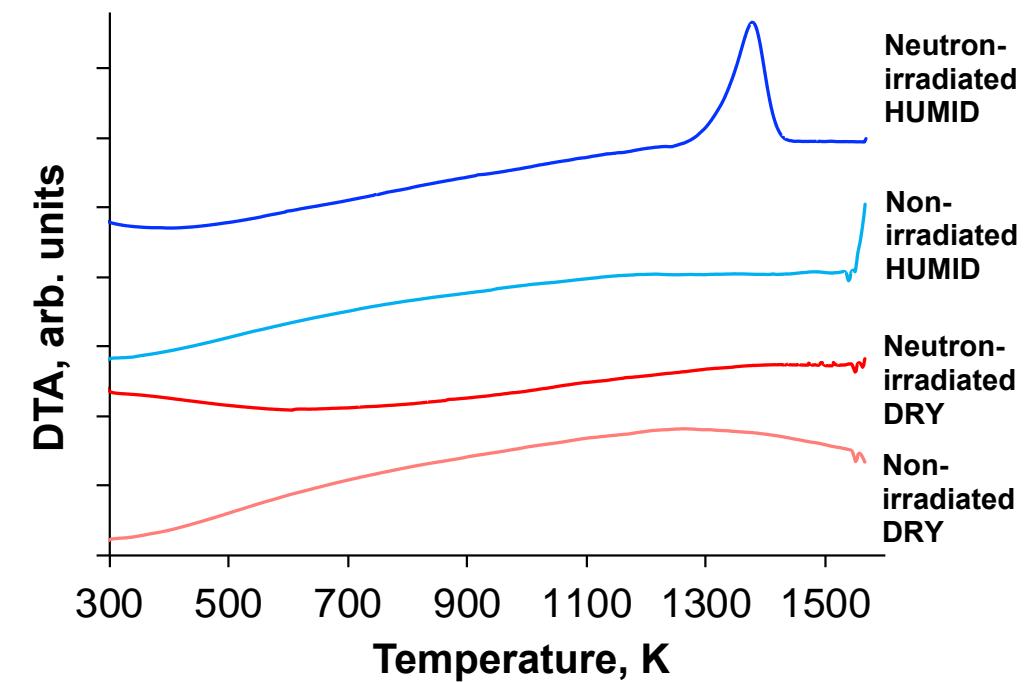
Fig. 2. DTA signal of non-irradiated and neutron-irradiated beryllium pebbles in humid and dry airflow.

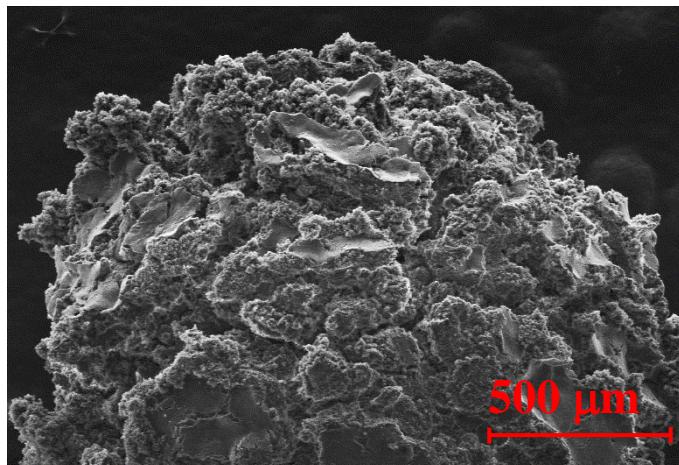
Fig. 2. Non-irradiated beryllium pebble after treatment in humid airflow

Beryllium pebbles after thermal treatment have considerably increased in size and a complex layer of BeO on the surface is observed.

Furthermore, the complex structures include systems of cracks and microcracks of varying depth and length.

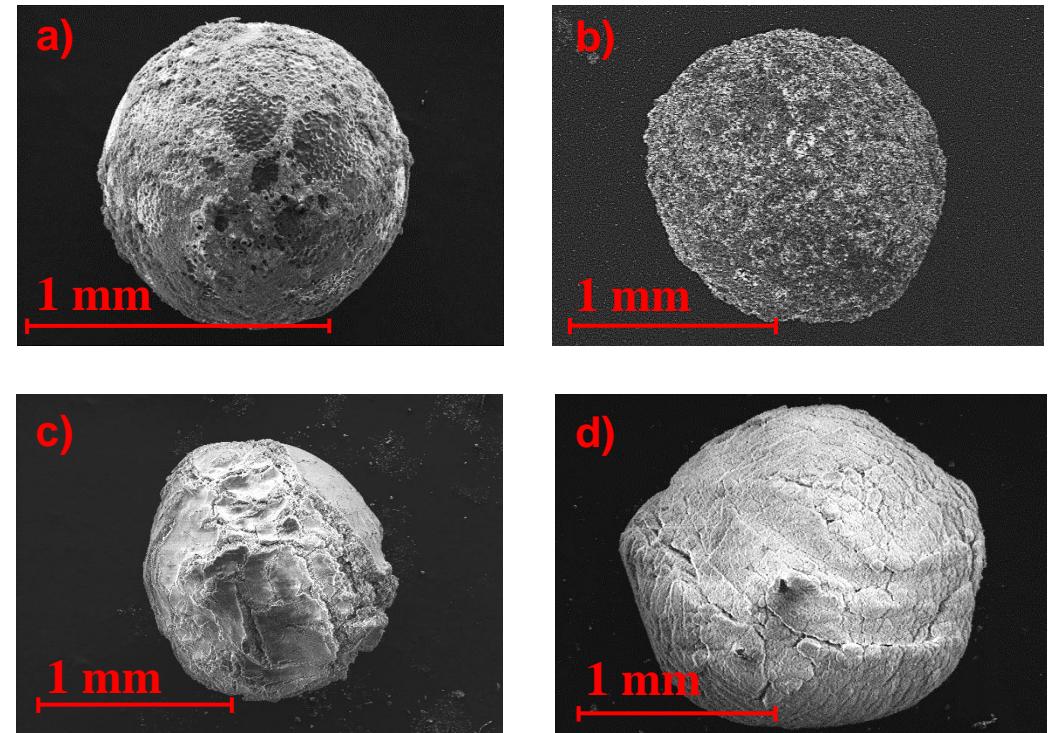
Fig. 1. Beryllium pebbles after thermal treatment under SEM:
a) non-irradiated DRY, b) neutron-irradiated DRY,
c) non-irradiated HUMID, d) neutron-irradiated HUMID

Investigating the Be pebbles using a scanning electron microscope (SEM) revealed different types of micro- and nano-sized structures.

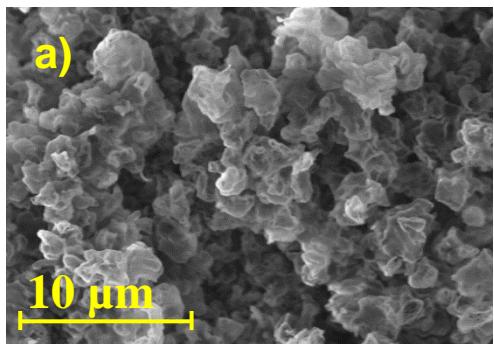
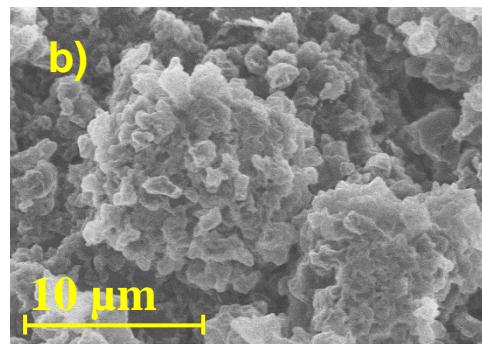
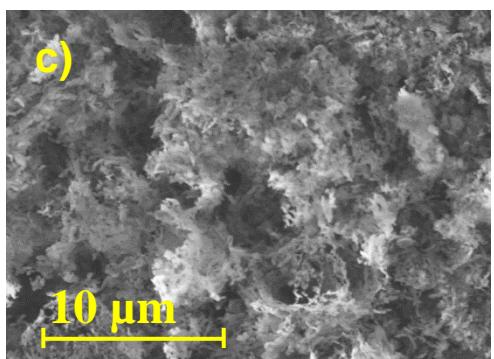
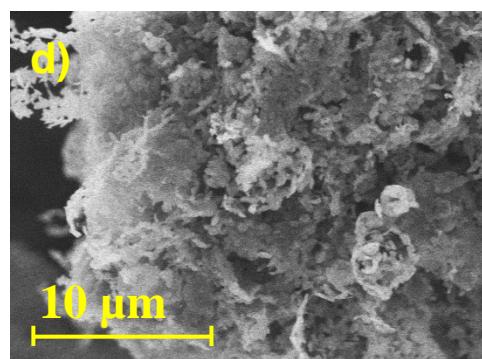
Fig. 1. Beryllium pebbles **after** thermal treatment under SEM at $4,5 \cdot 10^3$ magnification:
a) non-irradiated DRY, b) neutron-irradiated DRY,
c) non-irradiated HUMID, d) neutron-irradiated HUMID

Furthermore, magnifying the treated pebbles differences in the shape of BeO are observed.

Dry air appears to create cluster-like oxide particles, whereas humid air flow produces needle-like particles, which are substantially smaller and, thus, fragile.

Some spherical structures are visible on neutron-irradiated samples, indicating that a de-trapping of gas has likely occurred. Such structures **warn of probable trapped gas release** during LOVA/LOCA.

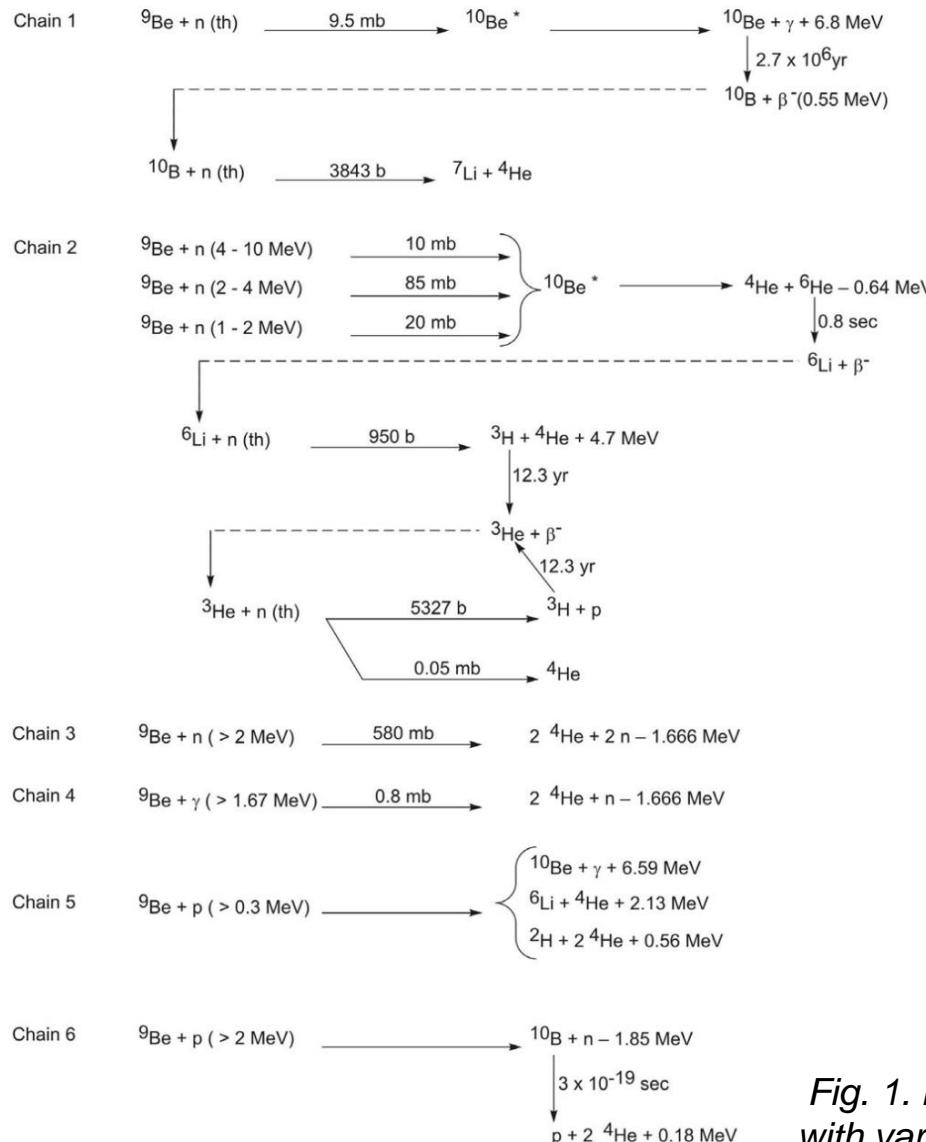
Fig. 1. Beryllium chain reactions with various particles [6]
